Manhole Inspection Summary

Manhole # S33KK1007MH

Insp Date: **3/2/07 12:27 PM**

Location Address: **105 CHARLCOTE RD**

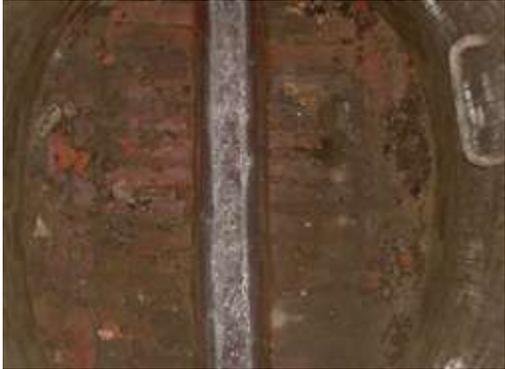
Top View

Evidence of surcharge - Bench debris.

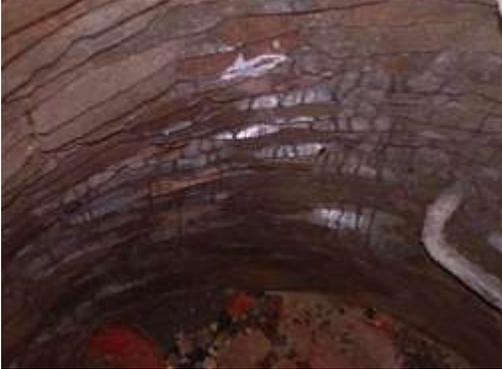
Defect

Corbel and Barrel infiltration.

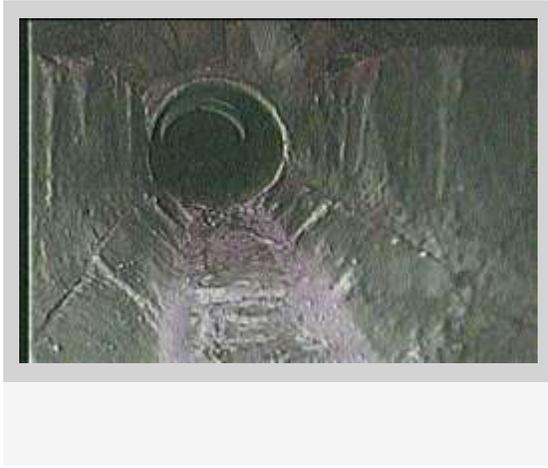
**6 in. Circular Gravity Sewer
Pipe Out @ 12 O'Clock**

Infiltration: **Evidence** Pipe Seal Cond: **Cracked**

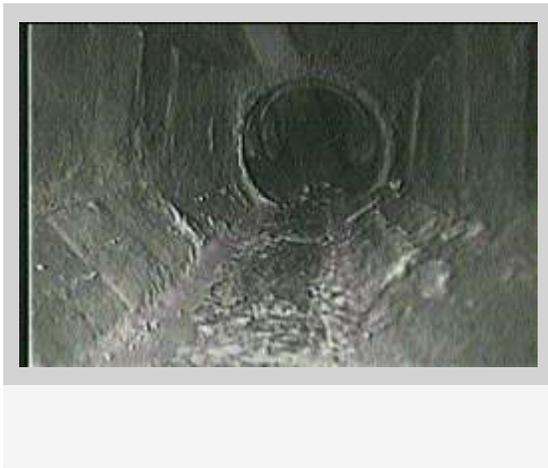
**6 in. Circular Gravity Sewer
Pipe In @ 6 O'Clock**

Infiltration: **None** Pipe Seal Cond: **Cracked**
